FLOOD HAZARD ANALYSES PASSUMPSIC RIVER

Lyndon, Vermont

January 1973

<u>Page</u>
Introduction	1
Procedures and Techniques	2
Flood Delineations	2
Photographs	4
Following Page 7 :	
Map of Study Area and Index to Flood Hazard Area Maps - 1 Sheet	
Flood Hazard Area Maps - 10 Sheets	
Selected Valley Sections - 2 Sheets

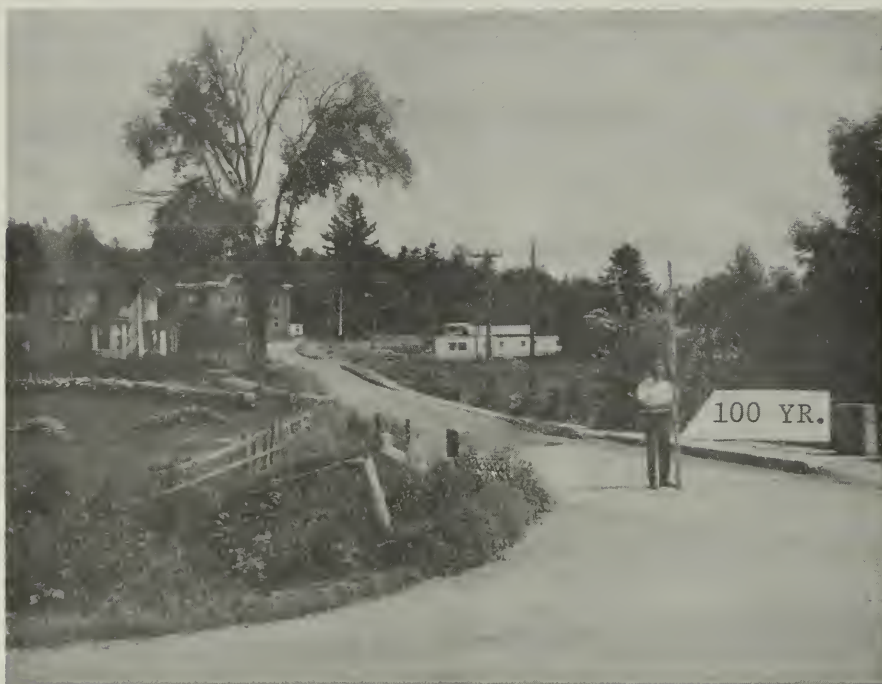
Bridge over Wheelock Branch at Lyndon
(Cross-Section W4)

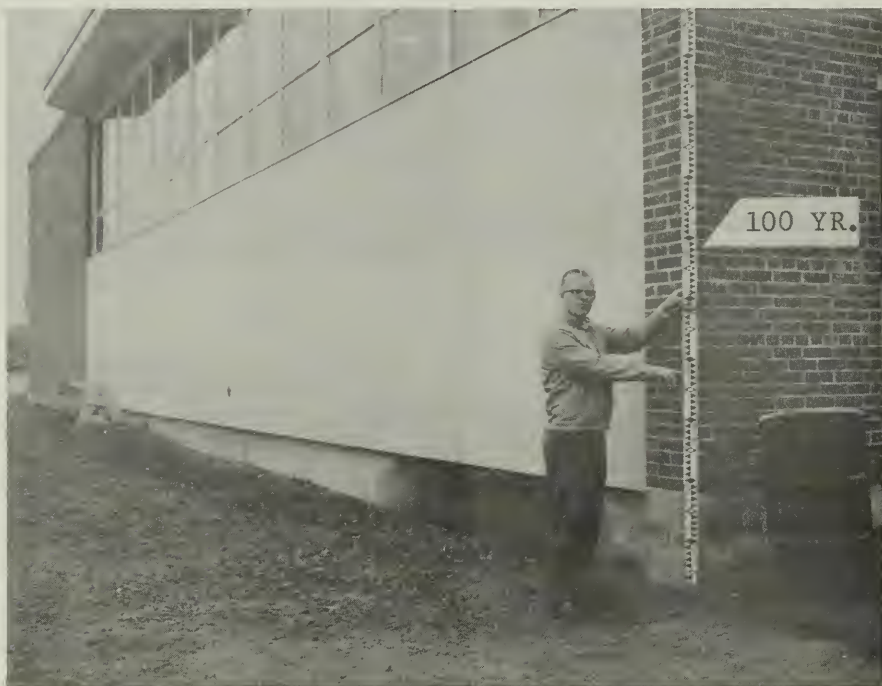
Southwest corner of Lyndonville Graded School
(Cross-Section 37)

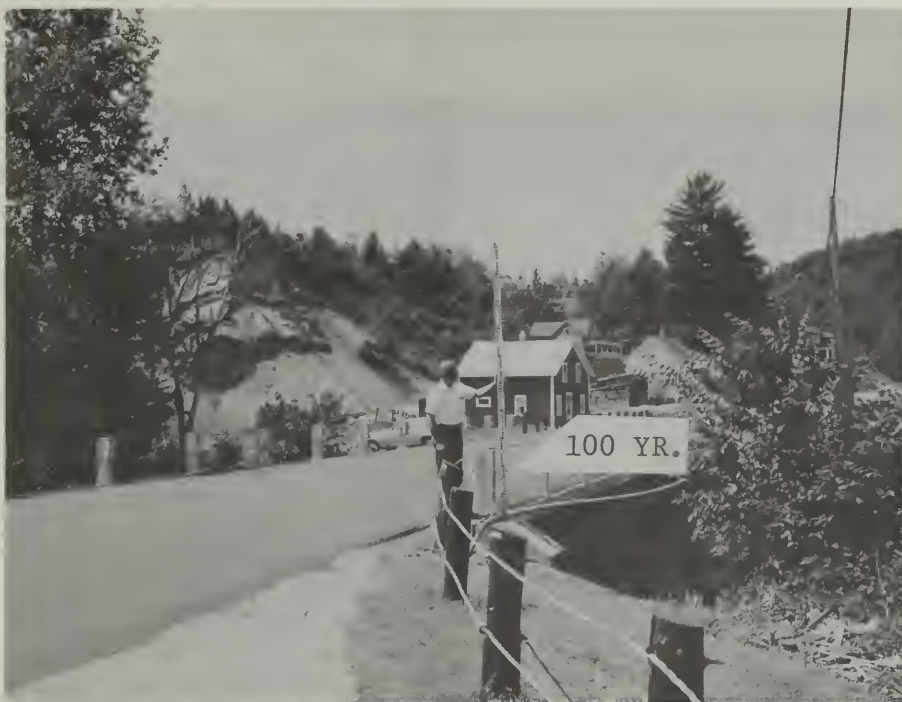
Bridge over East Branch, Vermont
Route 114 (Cross-Section 23)

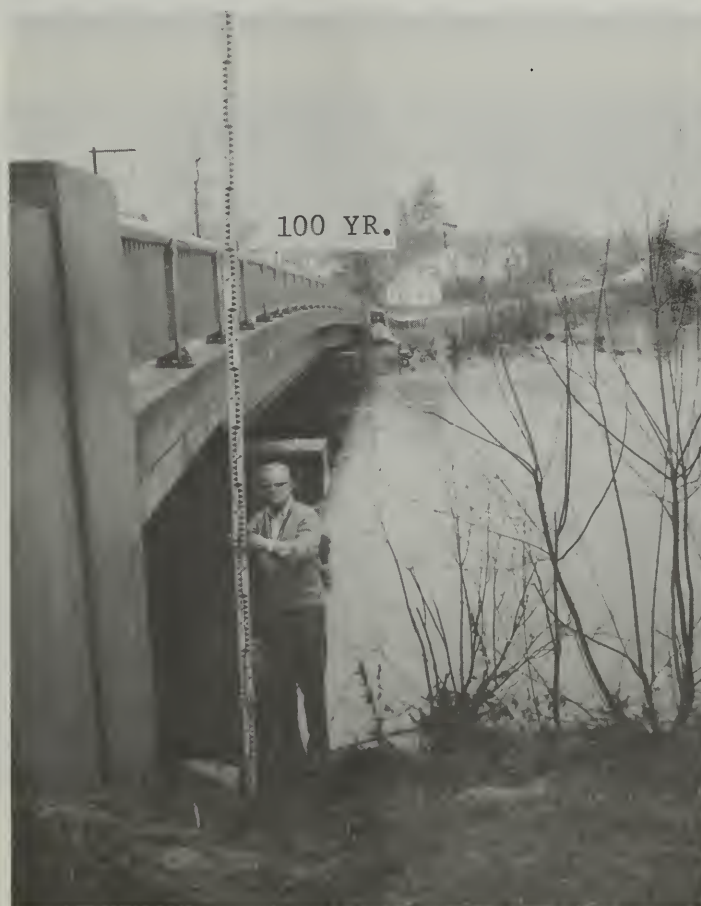
Bridge over Passumpsic River, Vermont
Route 122 at Lyndonville
(Cross-Section 38)

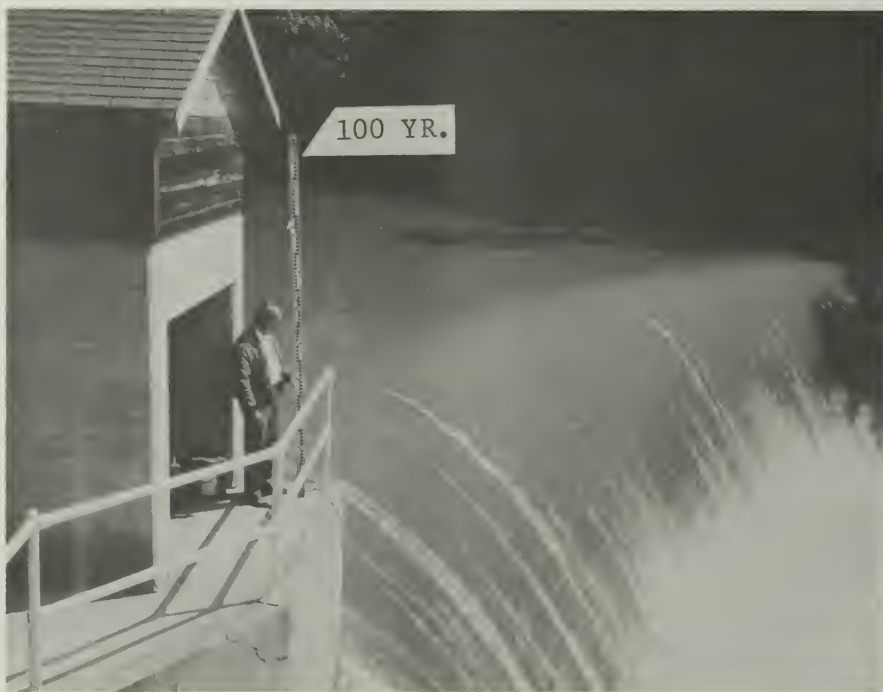
Crest of Lyndonville Electric Company dam
(Cross-Section 56)

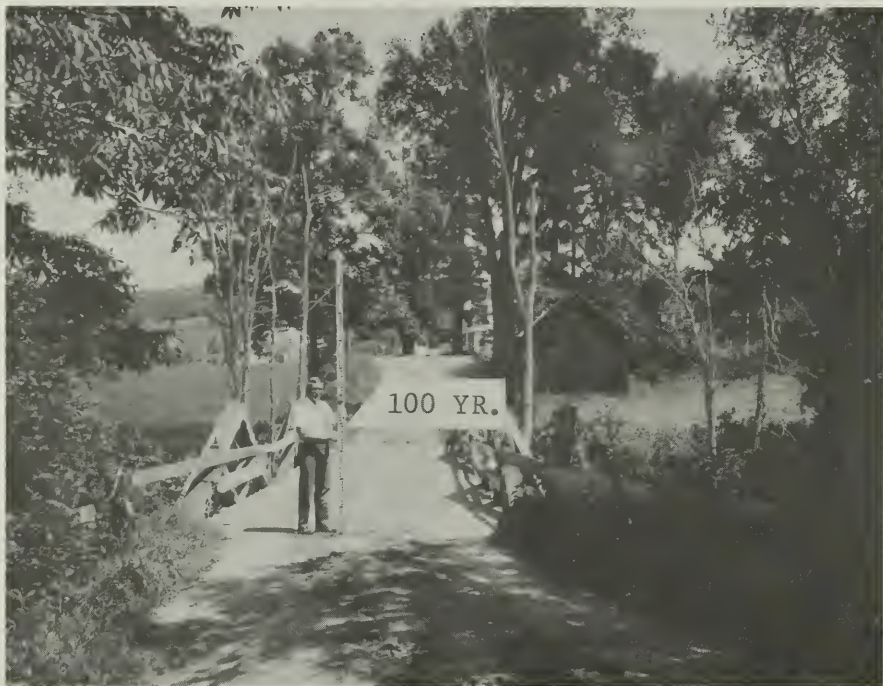
Bridge over Miller Run
(Cross-Section M7)

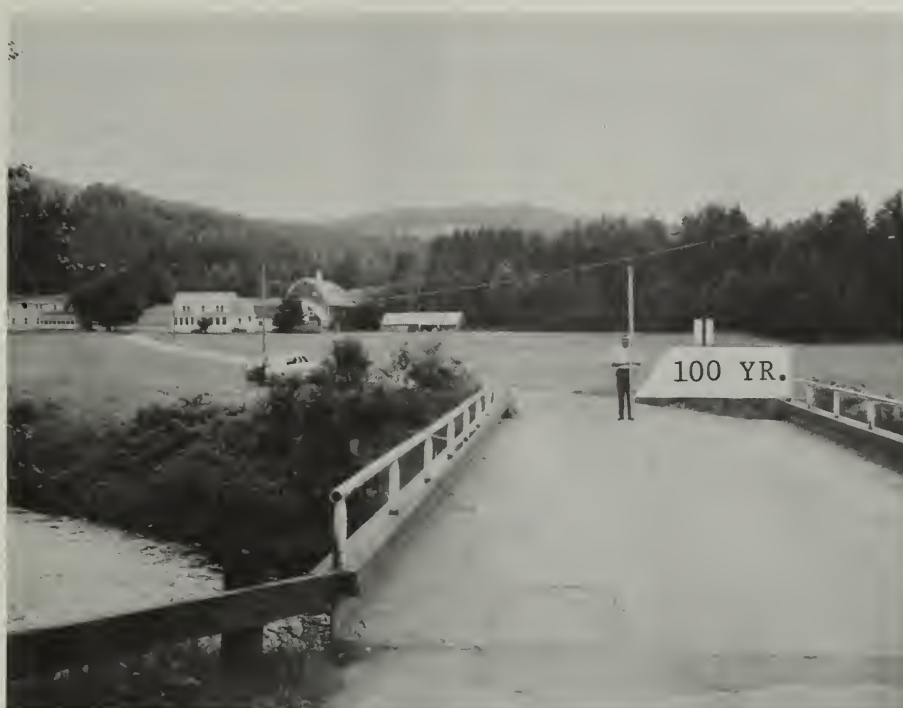
Bridge over East Branch
(Cross-Section 18)

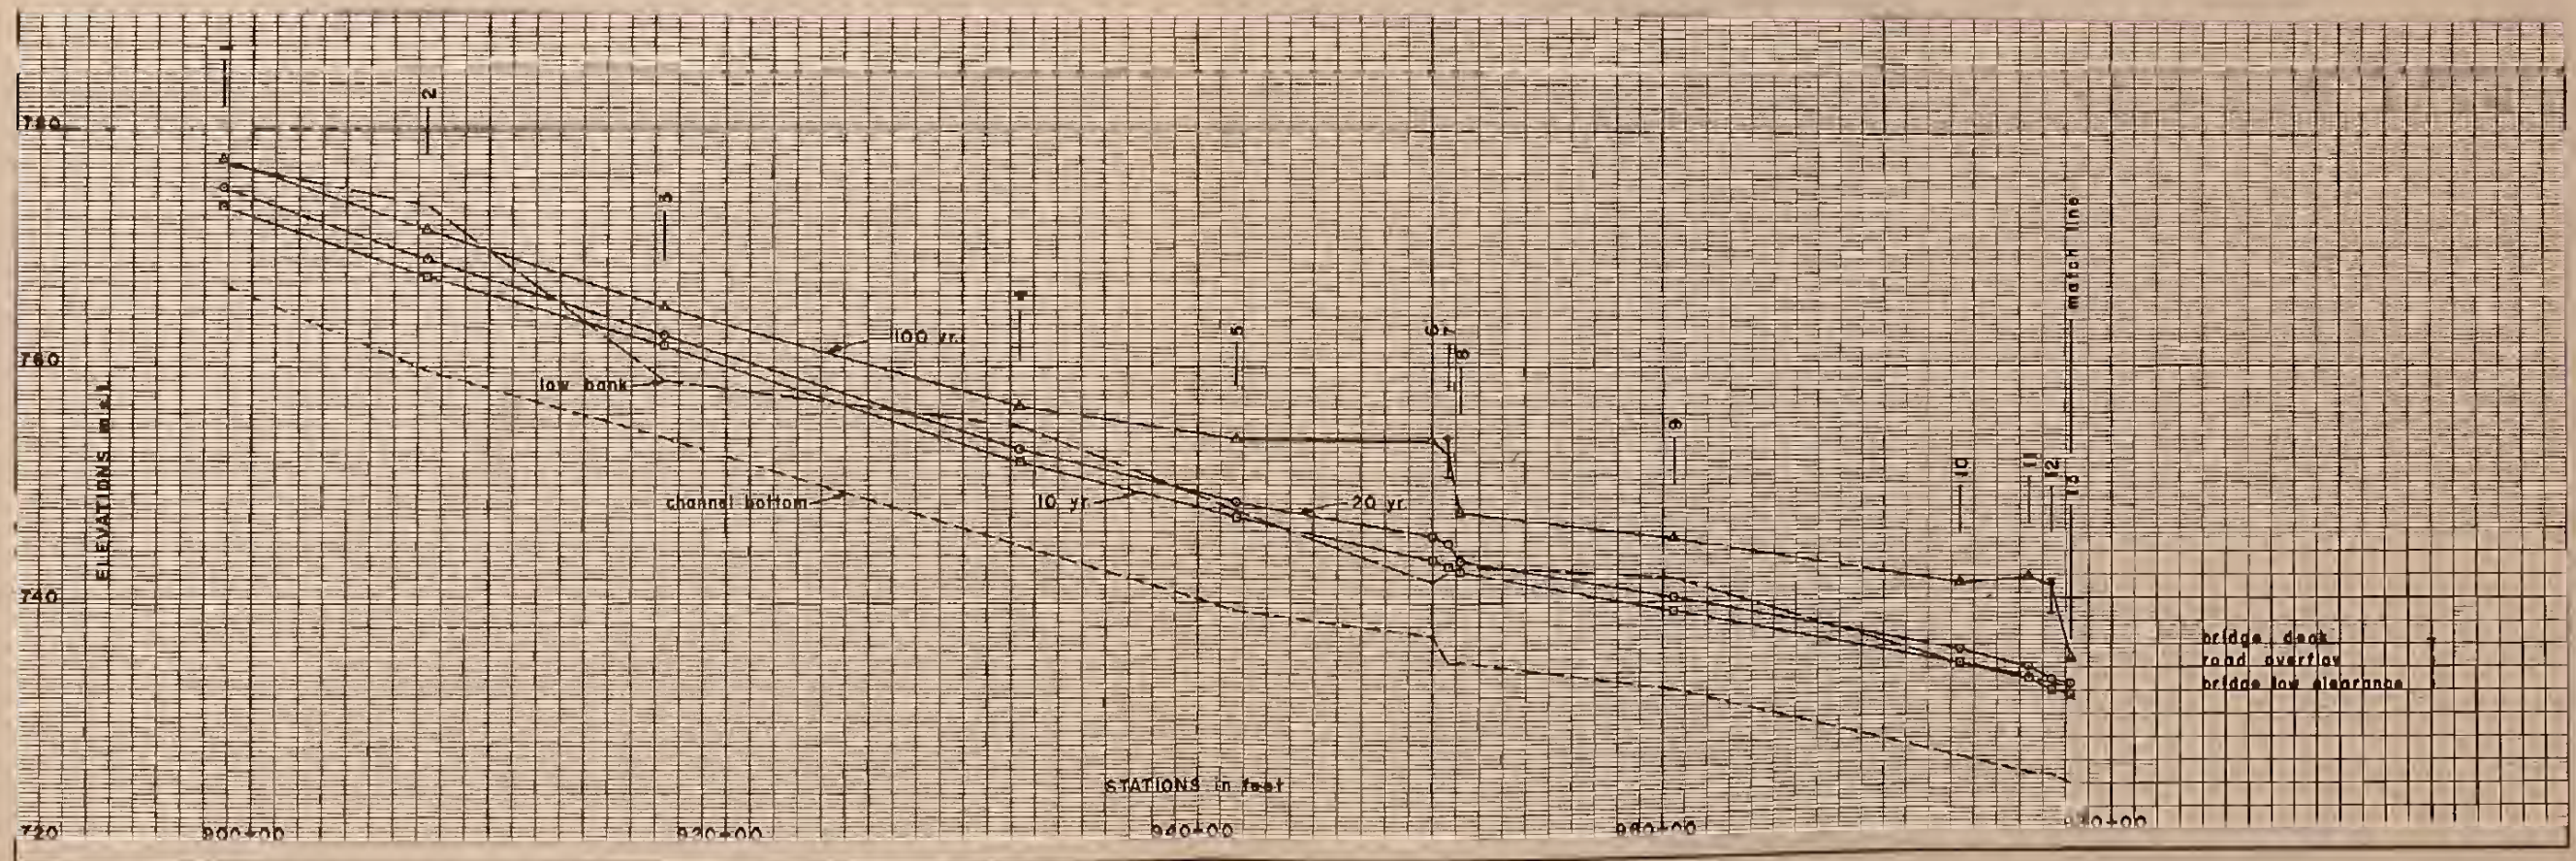
Semi-controlled mosaic prepared from State of Vermont aerial photography (VT-62-H) flown May 13, 1962

FLOOD HAZARD AREAS
 PASSUMPSIC RIVER-EAST BRANCH
 LYNOON, VERMONT
 JANUARY 1973 SHEET 2 OF 10
 U. S. DEPARTMENT OF AGRICULTURE
 SOIL CONSERVATION SERVICE

The study results following are in the form of aerial photo plan views of the floodplain, with expected floodwater profiles plotted on the lower part of the sheets. Due to variations in relief, the edges of the flood hazard areas outlined are approximate. In order to accurately determine the flood hazard at a point near the edge of the floodplain, the user can locate the point on the map, and read the expected floodwater elevation from the corresponding location on the profile. The safety of the location can then be determined by inspection, or if necessary, by surveying its mean sea level elevation.

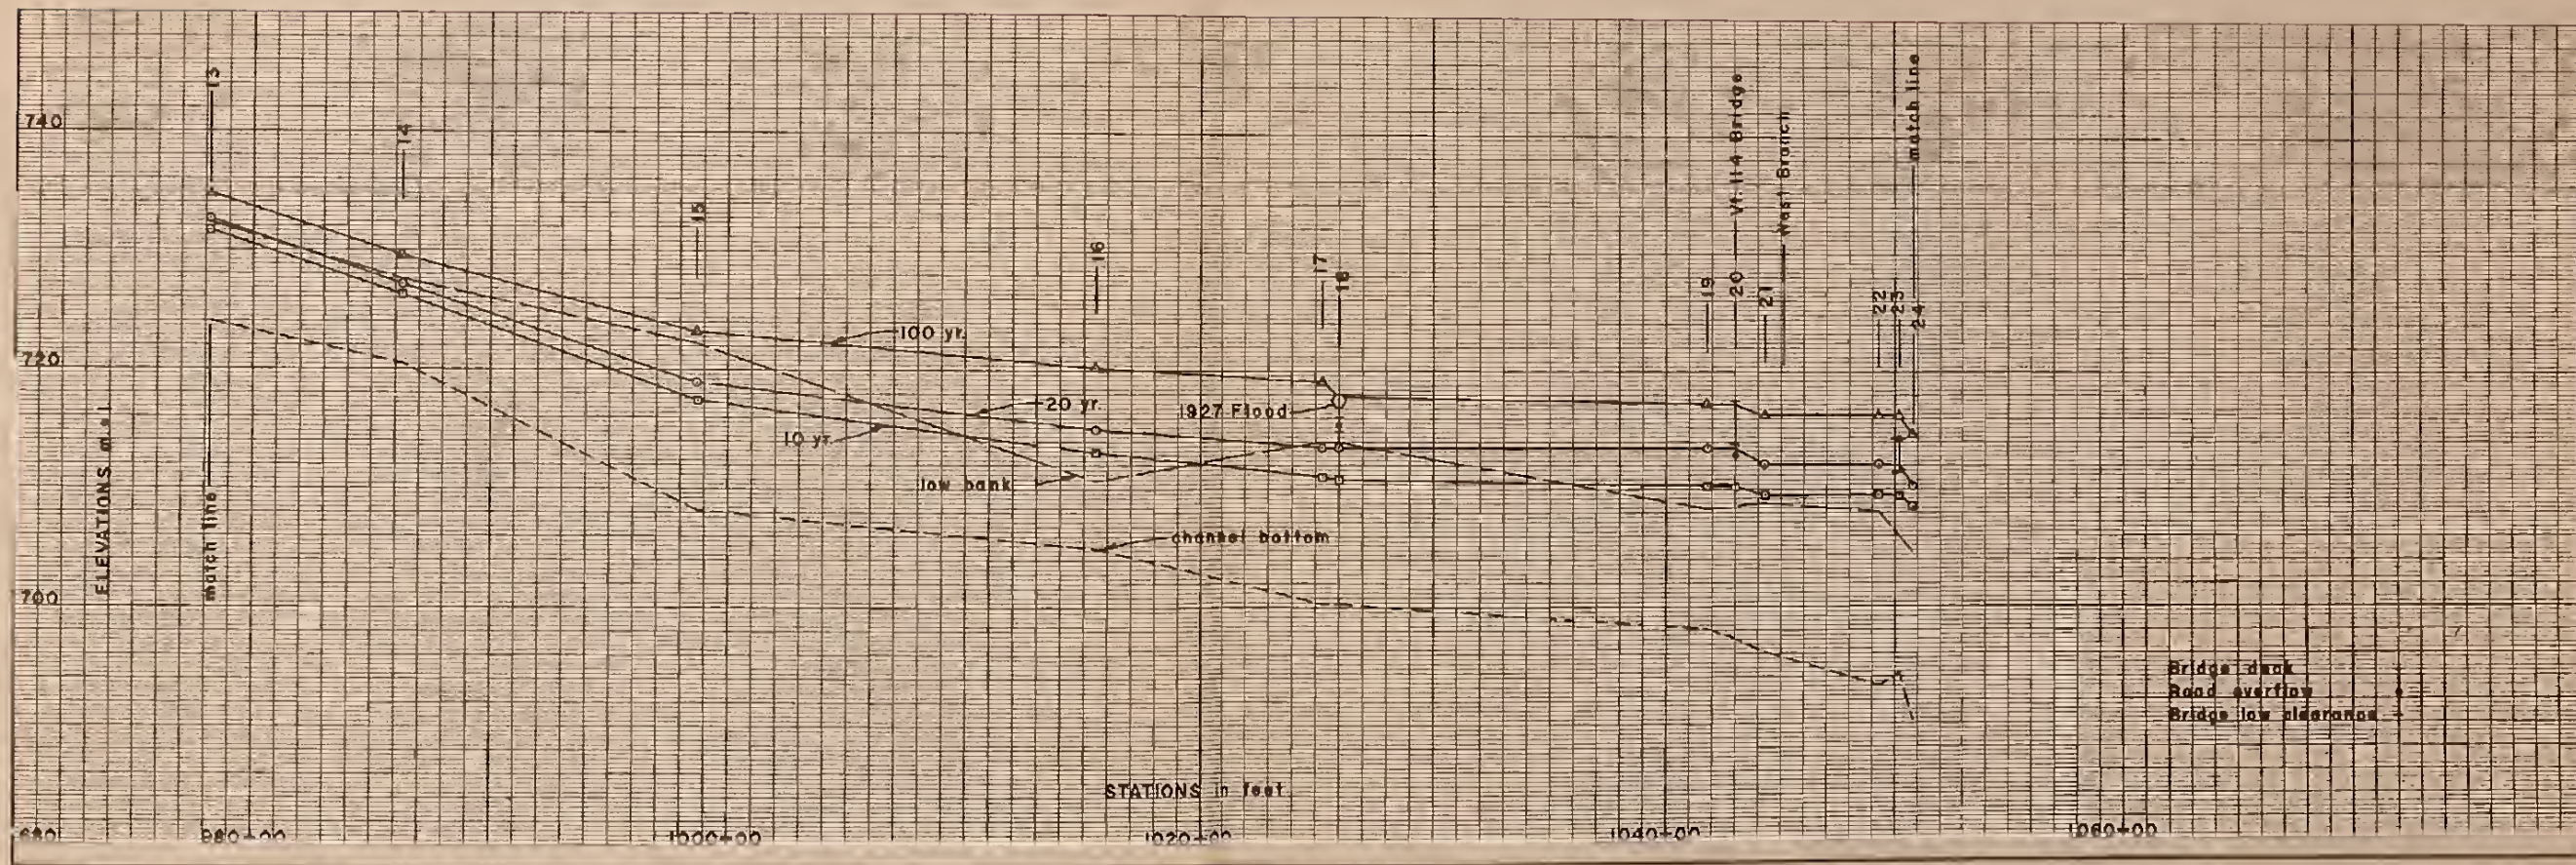
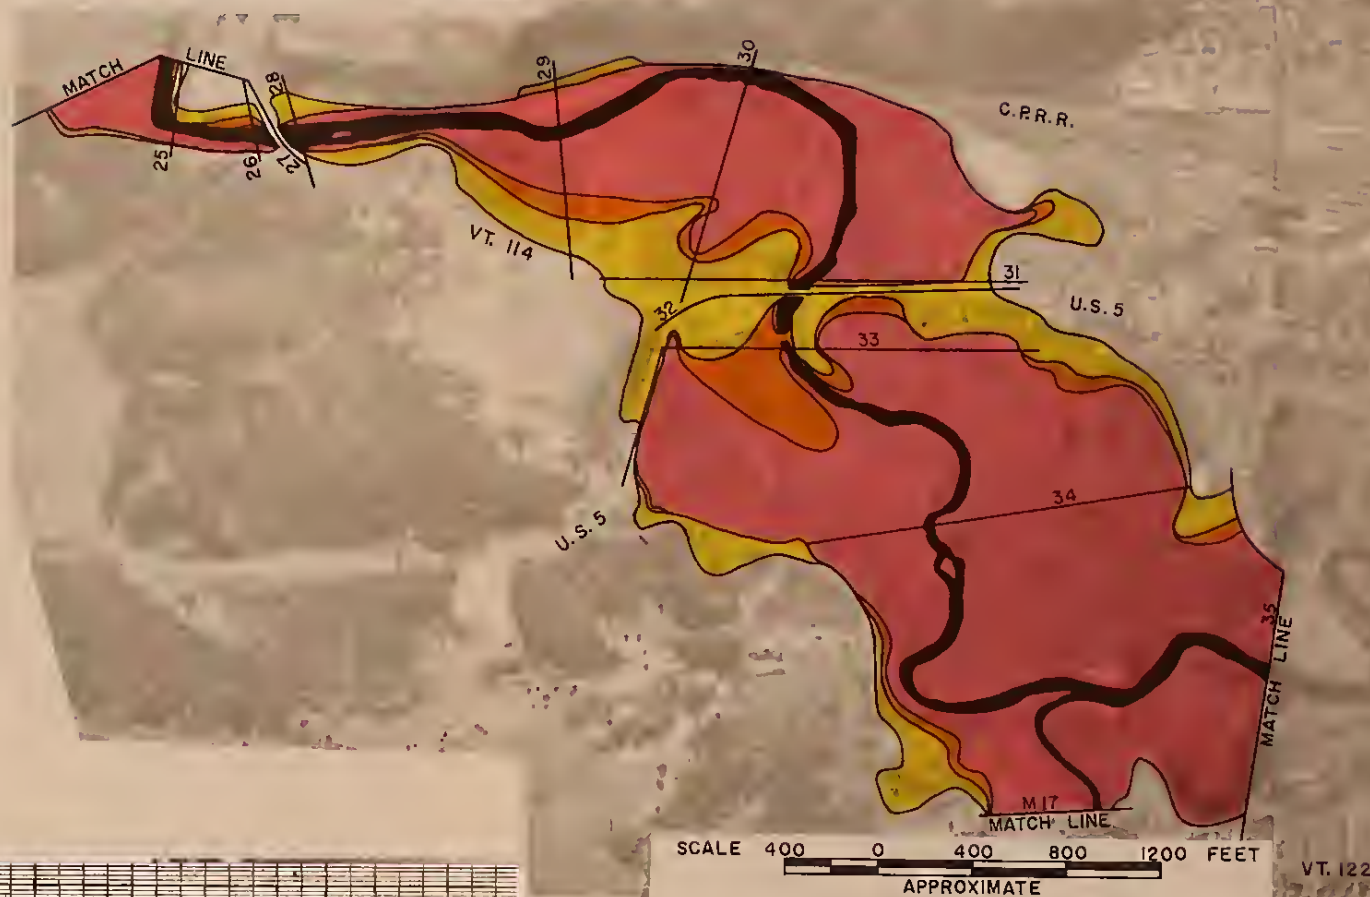
Semi-controlled mosaic prepared
from State of Vermont aerial
photography (VT-62-H) flown May 13, 1962

FLOOD HAZARD AREAS
PASSUMPSIC RIVER
LYNDON, VERMONT
JANUARY 1973 SHEET 3 OF 10
U. S. DEPARTMENT OF AGRICULTURE
SOIL CONSERVATION SERVICE

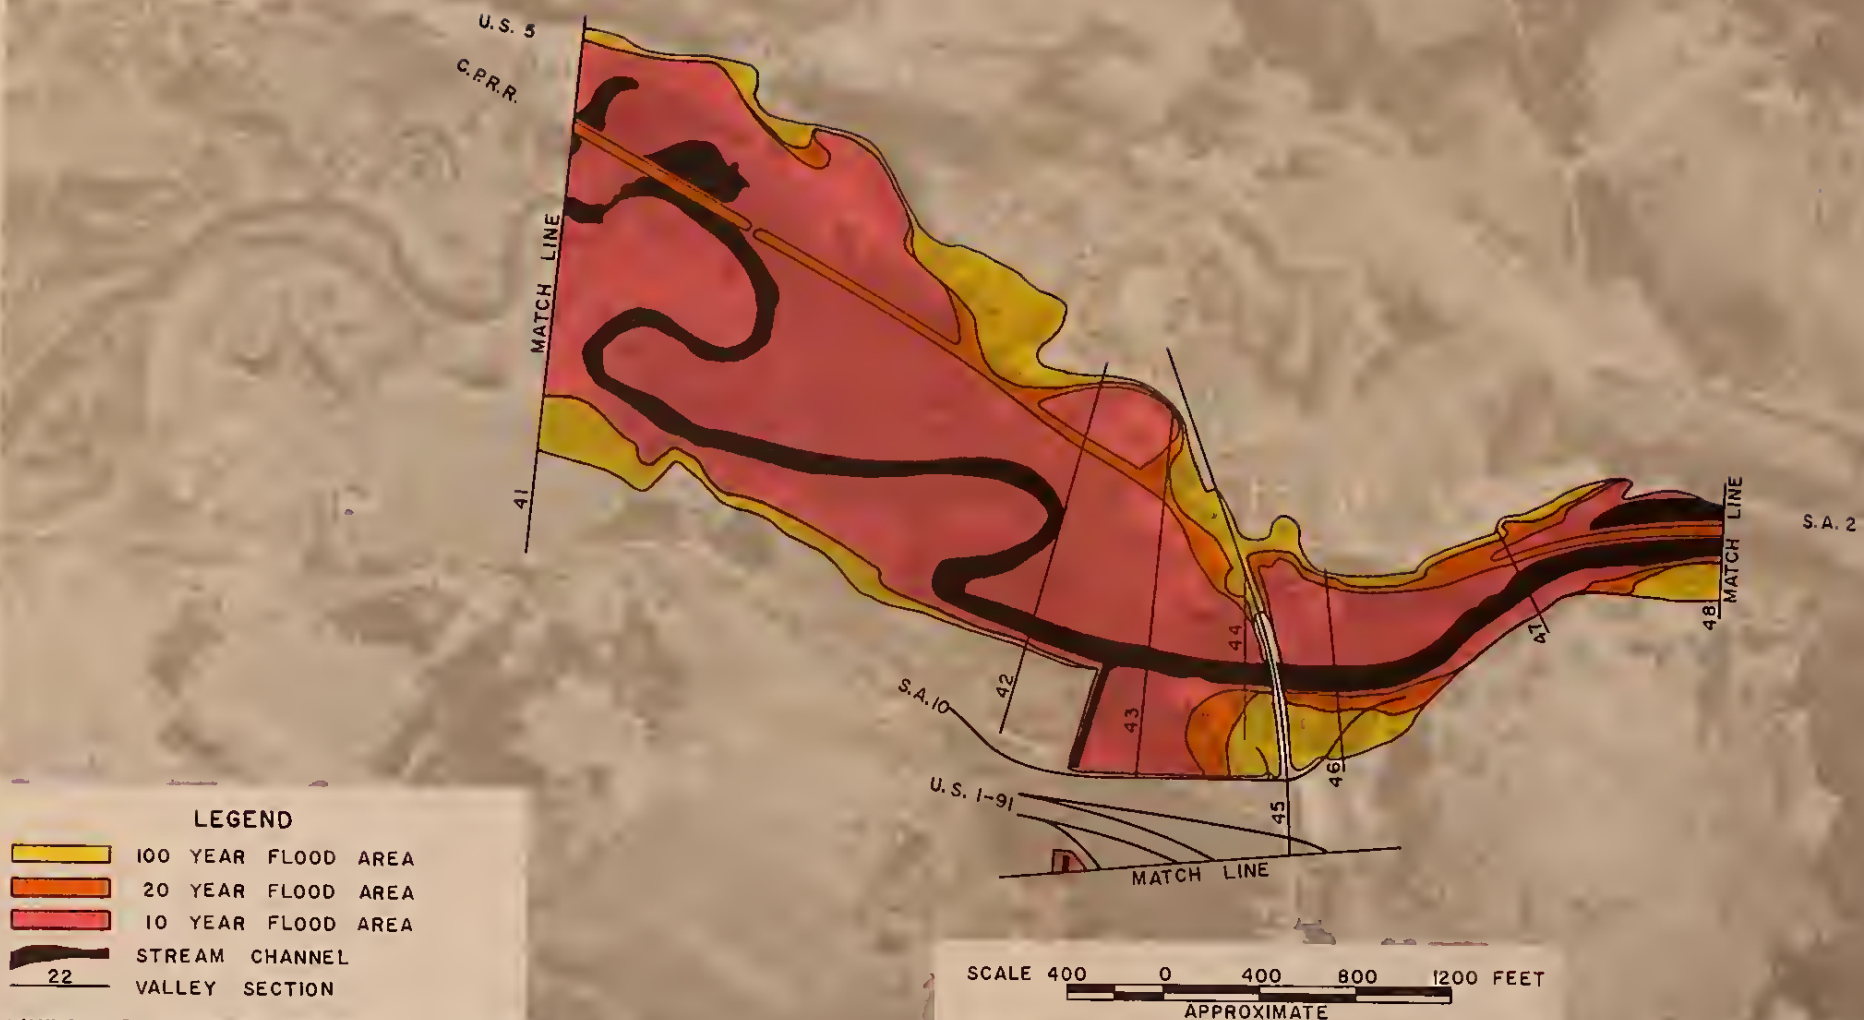
FLOOD HAZARD AREAS
PASSUMPSIC RIVER
LYNDON, VERMONT
JANUARY 1973 SHEET 5 OF 10
U. S. DEPARTMENT OF AGRICULTURE
SOIL CONSERVATION SERVICE

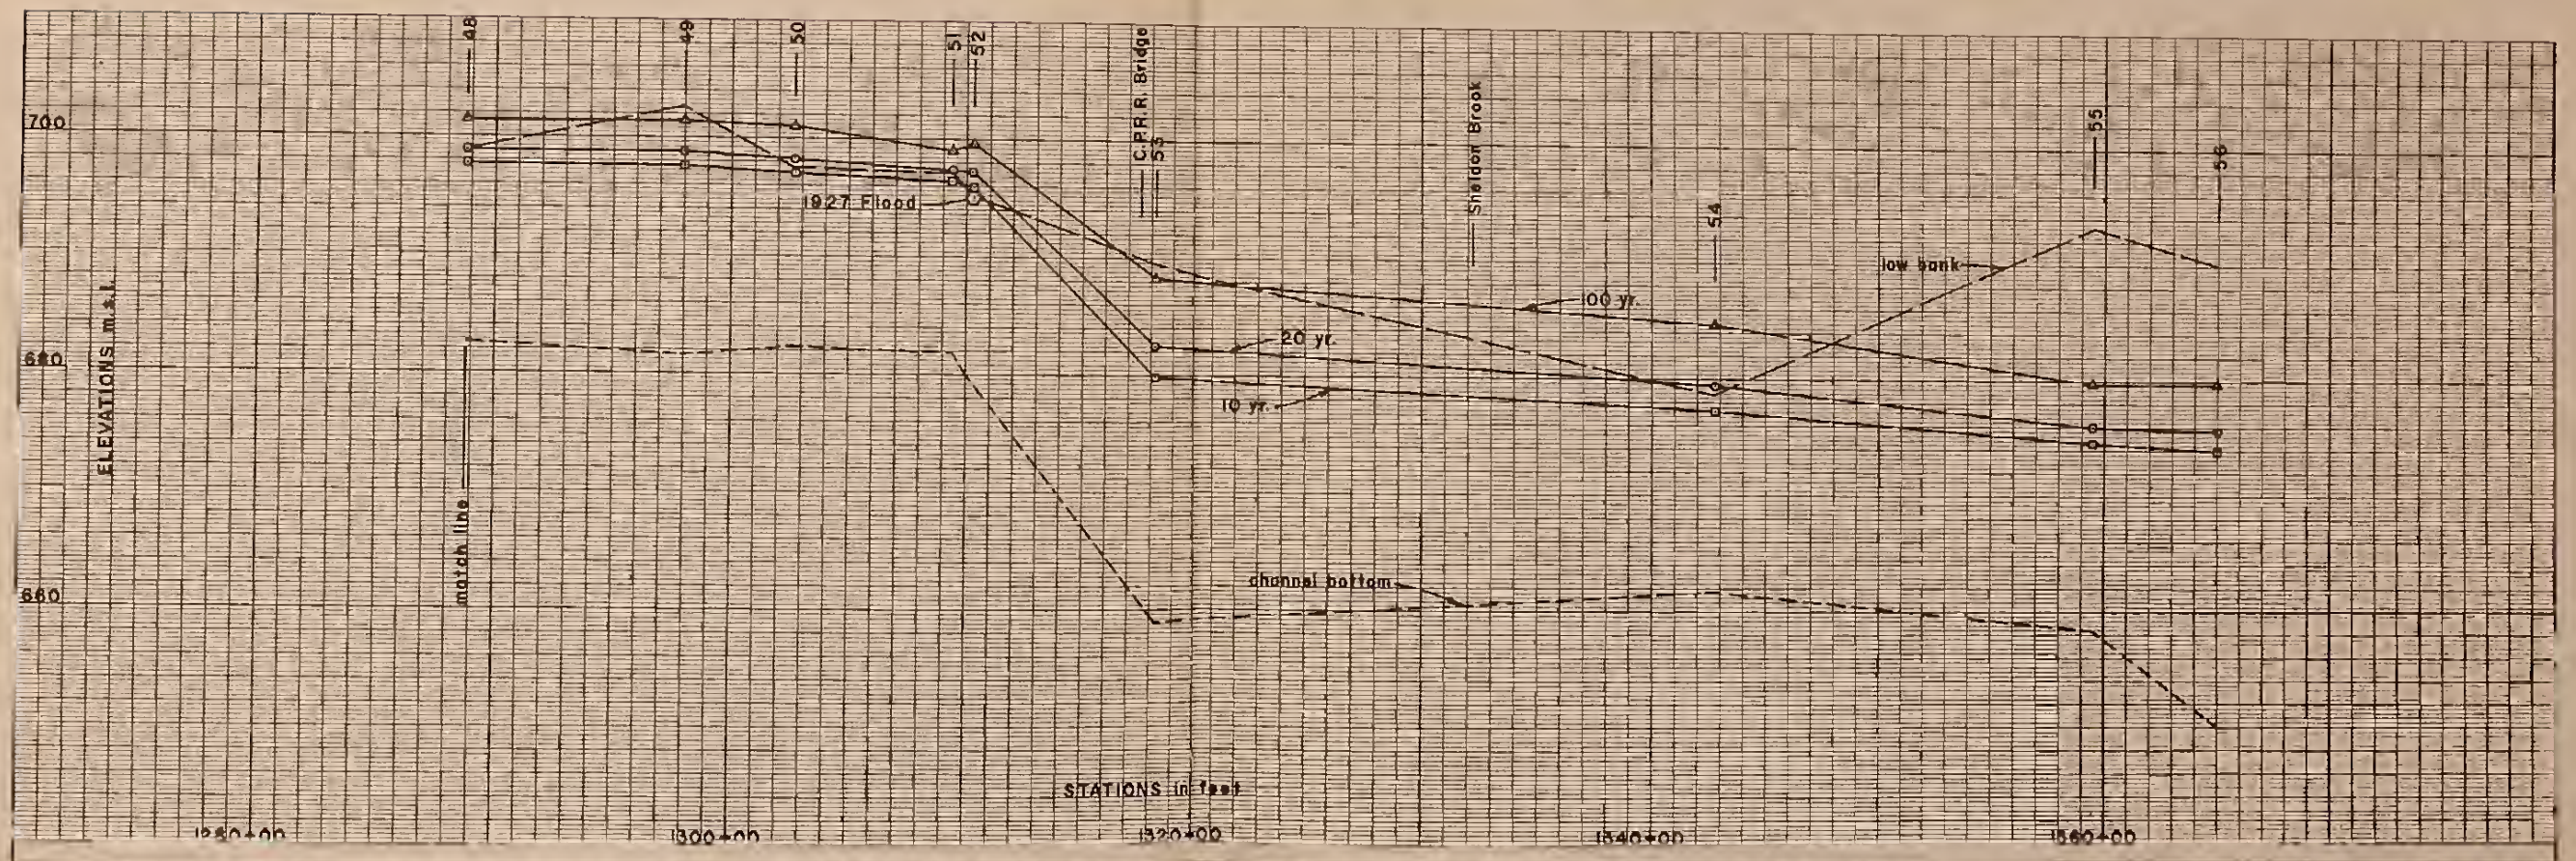
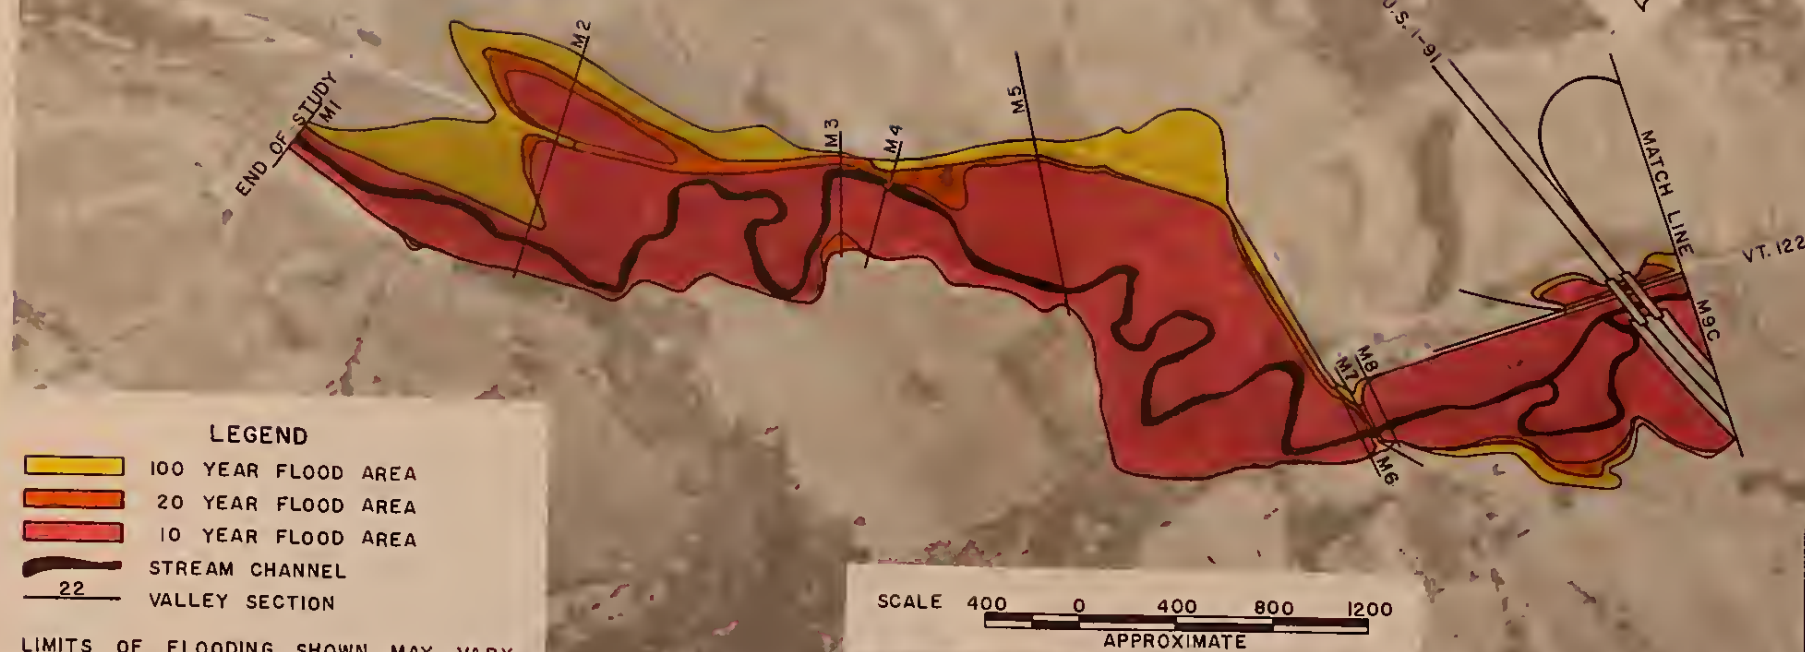
FLOOD HAZARD AREAS

MILLER RUN
LYNDON, VERMONT

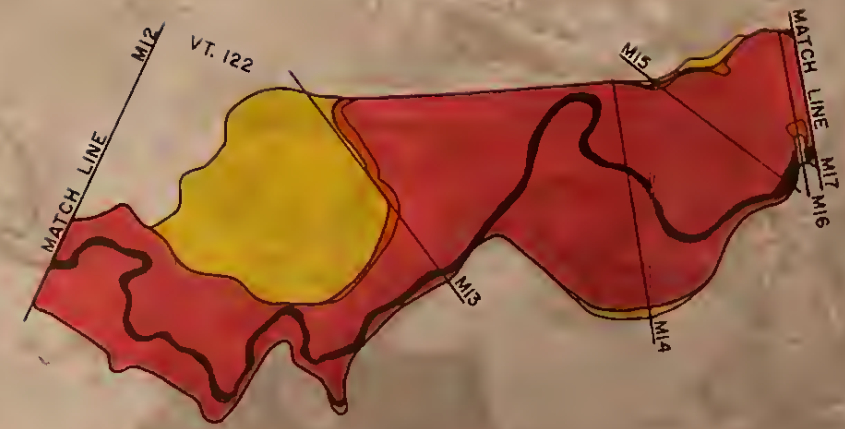
FLOOD HAZARD AREAS
MILLER RUN
LYNOOS, VERMONT
JANUARY 1973
SHEET 9 OF 10
U. S. DEPARTMENT OF AGRICULTURE
SOIL CONSERVATION SERVICE

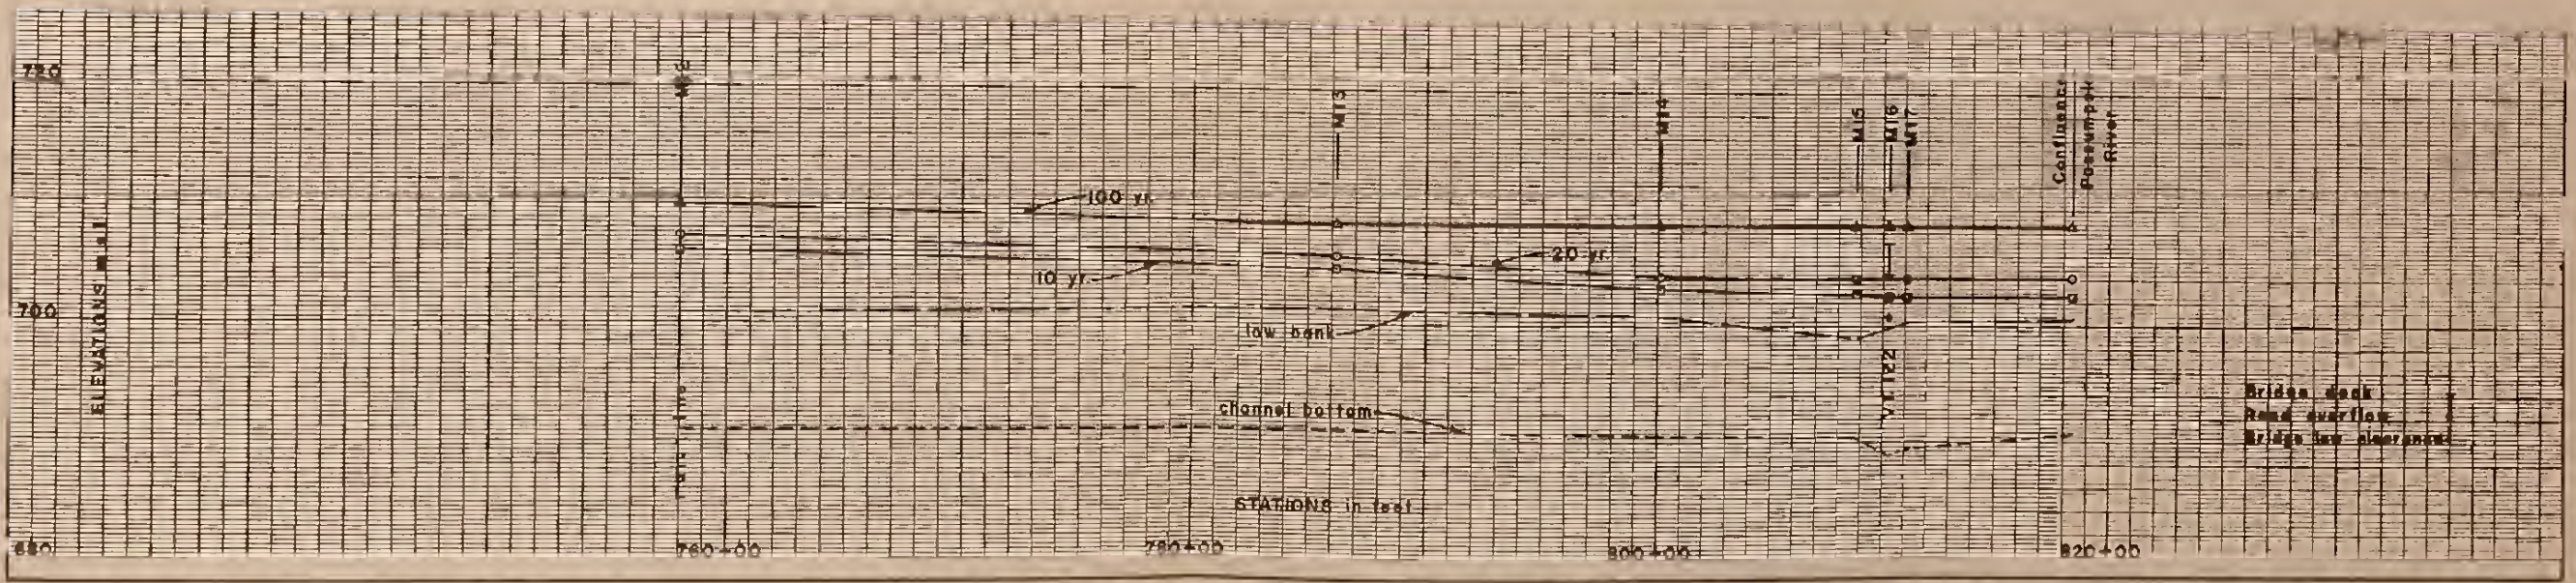
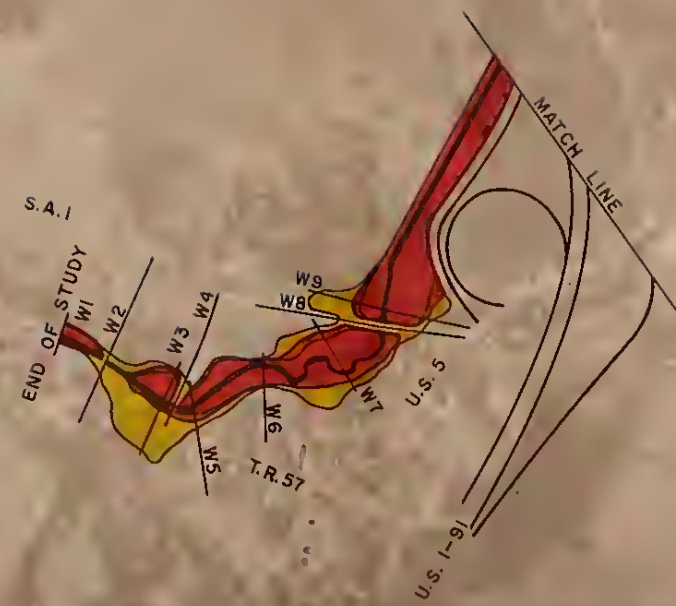
FLOOD HAZARD AREAS
SOUTH WHELOCK BRANCH
LYNDON, VERMONT
JANUARY 1973 SHEET 10 OF 10
U. S. DEPARTMENT OF AGRICULTURE
SOIL CONSERVATION SERVICE

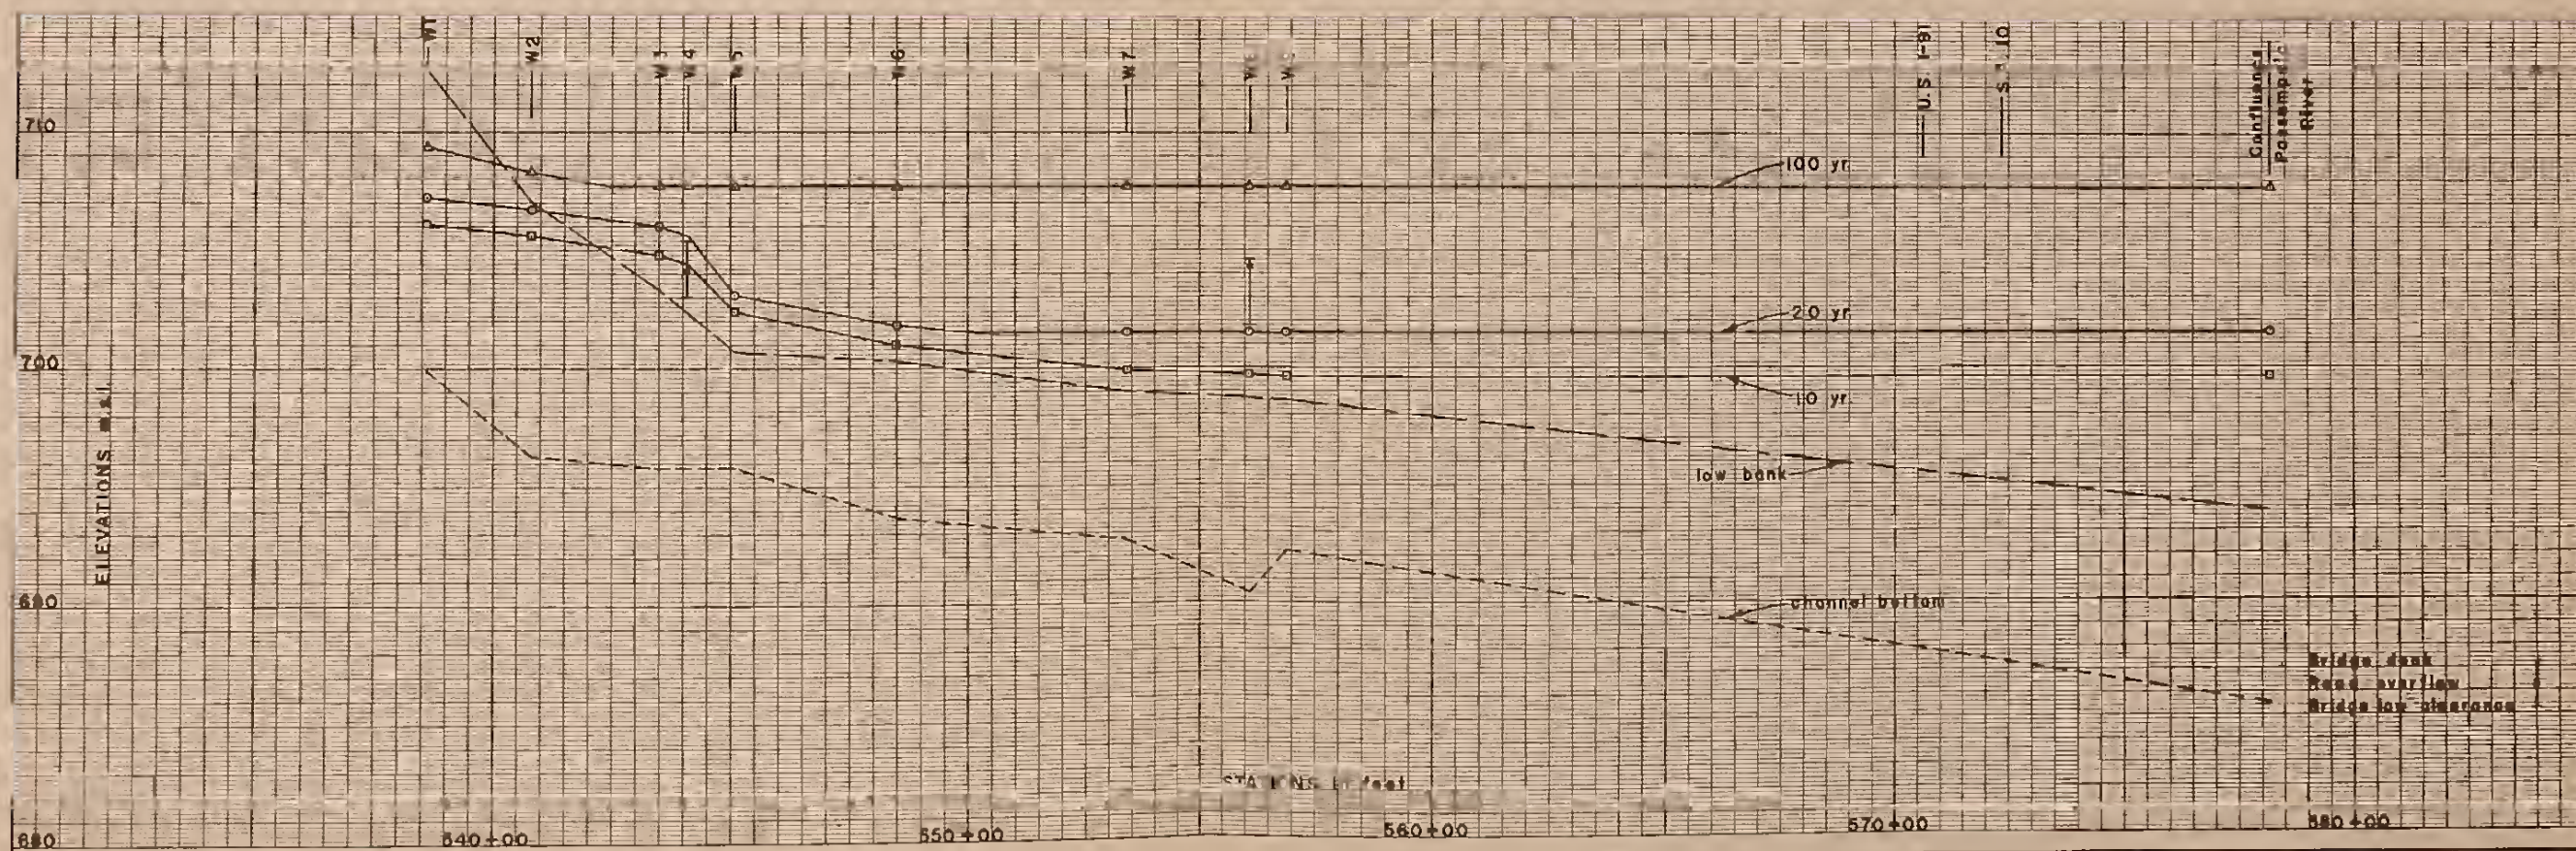
ELEVATIONS (m.s.l.)

VALLEY SECTIONS PASSUMPSIC RIVER LYNDON, VERMONT	
U. S. DEPARTMENT OF AGRICULTURE SOIL CONSERVATION SERVICE	
Designed by _____	Date _____
Drawn R. H. B.	Approved by _____
Traced _____	Tide _____
Checked _____	Drawing No. _____

Flood runoff volumes and flows were developed on the basis of stream hydraulics, soil cover, land use, and rainfall data. Cross-section surveys of the stream channel and valley were used to determine water surface profiles for various flows; flood hydrographs for the ten, twenty, one hundred year and 1927 floods were then developed and routed through the watershed using computer programs prepared for this purpose. The resulting computer printout of water level at surveyed sections, to the nearest 0.1 foot, for each of the four floods, was used to prepare flood profiles and approximate plan views of the flooded areas. Frequency analyses indicated that the 1927 flood, occurring under present conditions, would be essentially identical to the 100 year flood, and therefore was not delineated separately on the maps and profiles. Actual flood elevations experienced in 1927 were taken from U.S. Corps of Engineers data and plotted at selected locations on the profiles.
